TECHNICAL REPORT M-279  
May 1980

ROOFING REPAIR MATERIALS FOR KOREAN  
RELOCATABLE BUILDINGS—TEST AND EVALUATION

# ROOFING REPAIR MATERIALS FOR KOREAN RELOCATABLE BUILDINGS—TEST AND EVALUATION

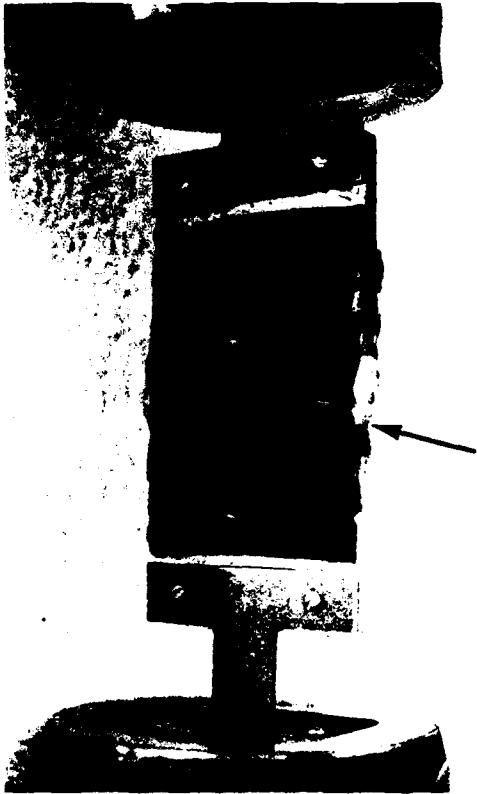
Figure 7. Enlarged tear in PS-5.

Specimen PS-5 was tested at -40°F (-40°C). A tear became visible at 800 cycles; at 1150 cycles, the tear extended halfway across the specimen. However, when the test was terminated at 1930 cycles, the tear still was not completely across the material (Figure 7).

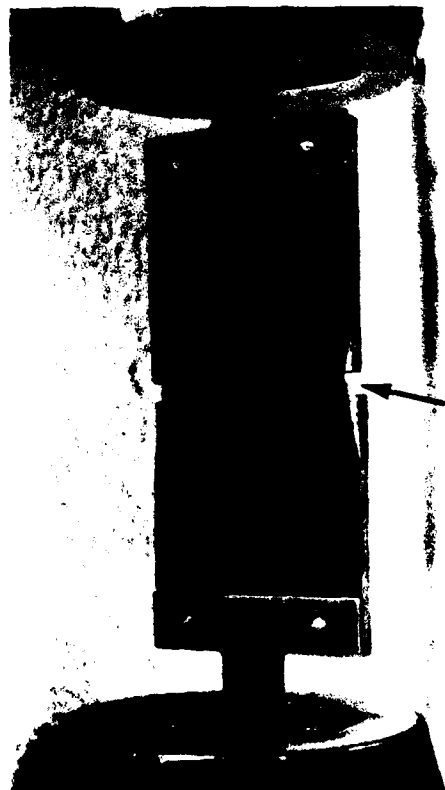
Figure 8. Maximum gap between test coupons.

Displacement in all three Contourflash tests was 3/8 in. (9.5 mm) (Figure 8).
